## Femoral Head-Trunnion Dissociation in Metal-on-Polyethylene Total Hip Arthroplasty: A Unique Case Report

**Journal Title:** Reconstructive Review

## Abstract

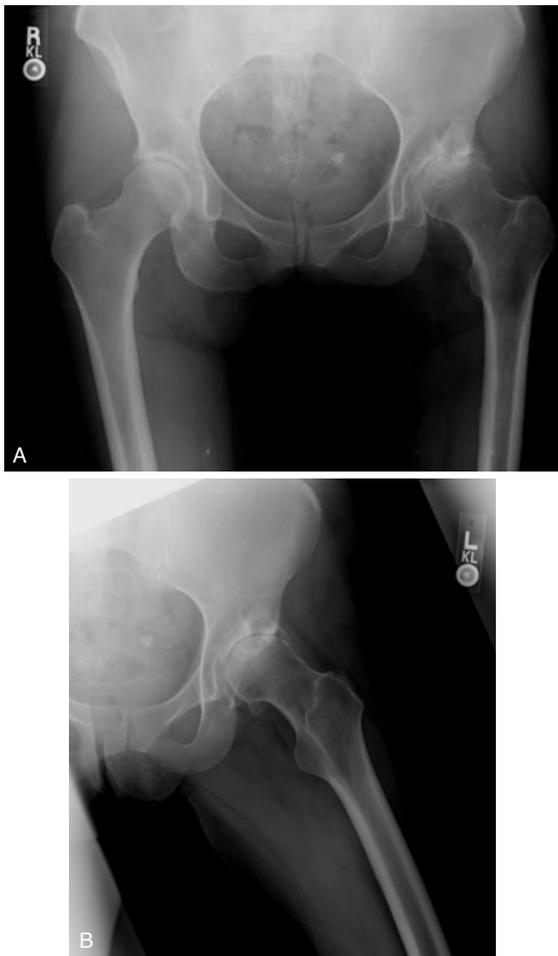
At initial presentation in 2007, the patient was a 55 year old female with BMI of 22.8 and past medical history consisting of lumbar radiculopathy. She reported a multiple year history of progressive left sided hip and groin pain and was found to have end stage left hip osteoarthritis on radiographs (Figure 1). After failure of conservative measures, the patient underwent elective left total hip arthroplasty in

Figure 1. Preoperative AP pelvis (A) and left hip frog leg lateral (B) radiographs from May 2007 demonstrating advanced osteoarthritis of the left hip.

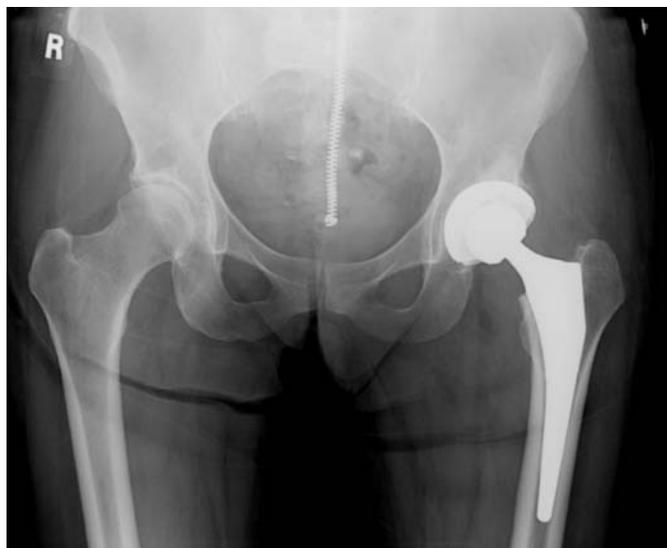
Figure 2. Initial post-operative AP pelvis radiograph from October 2007 after left total hip arthroplasty. Implants include Accolade I size 2.5 femoral component with 127° neck angle, Trident 52mm E acetabular shell, 32mm +4 CoCr head ball, and X3 32mm, 0 degree polyethylene liner.

October 2007 and tolerated the procedure well. Her hip implants consisted of an Accolade I TMZF size 2.5 femoral component with 127° neck angle, Trident 52mm E acetabular shell, 32mm +4 cobalt-chrome (CoCr) head ball, and an X3 32mm, 0 degree crosslinked polyethylene liner (Stryker Mahwah, NJ) (Figure 2). She had an unremarkable post-operative course. The patient returned to clinic in 2016, almost nine years after her initial surgery, now 63 years old and with a BMI of 23.5. Her complaints included 3 weeks of painless clunking and left hip mechanical symptoms. Imaging revealed significant metallic debris about the hip joint along with interval alignment change at the head-trunnion interface with the head ball now residing in a more varus angulation (Figure 3). Based on these findings suggesting trunnion compromise, surgical intervention was felt warranted and revision hip surgery was scheduled. Several days after evaluation, the patient presented to the emergency room with acute onset of significantly worsened left hip pain and found to have complete dissociation of the femoral head and trunnion (Figure 4).

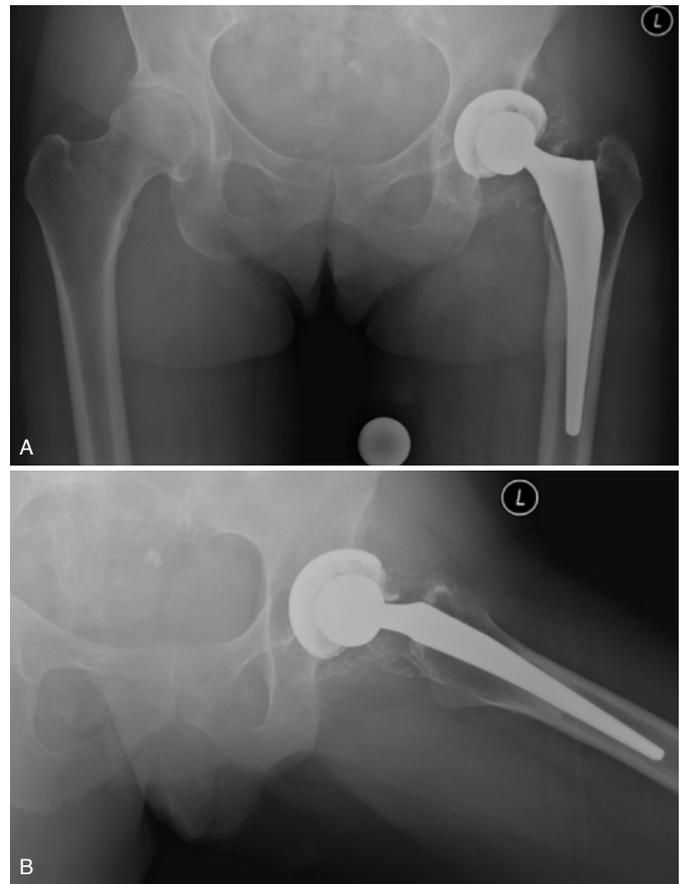
Figure 3. AP pelvis (A) and left hip frog leg lateral (B) radiographs taken in July 2016, almost 9 years after initial implantation. Best visualized on the AP view, there is now notable change in angulation at the head ball trunnion interface from prior imaging with the head ball now residing in a more varus conformation. Additionally, metallic debris can be visualized outlining the left hip capsule.

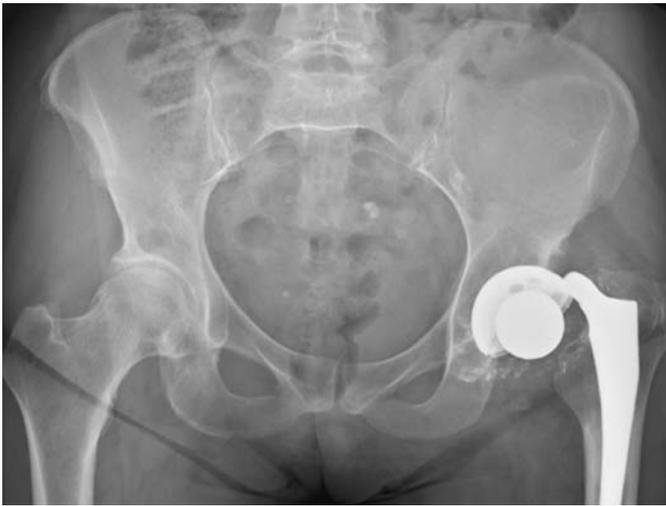
Figure 4. AP pelvis radiograph from August 2016 demonstrating complete femoral head ball and trunnion dissociation. Significant wear can be noted around the trunnion with again visualized metallic debris outlining the left hip capsule.

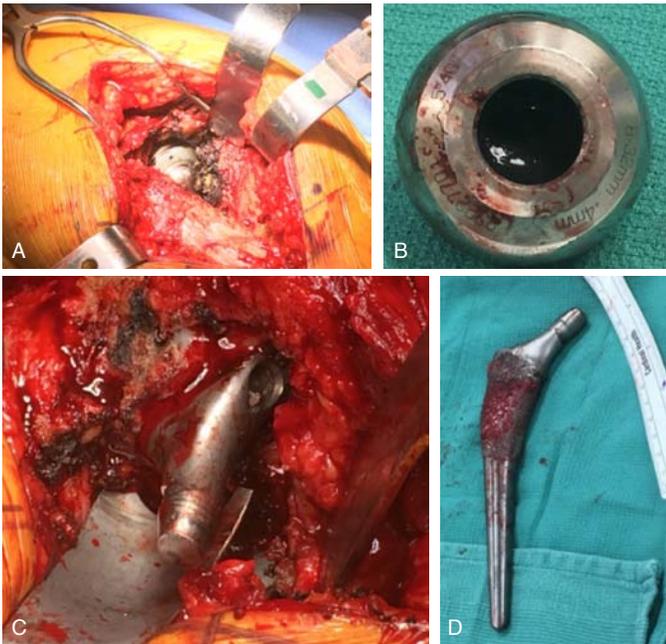
Figure 5. Intra-operative images from the revision left hip surgery in August 2016 (A) Posterior surgical approach to the left hip with obvious metallosis visualized in the soft tissues surrounding the implants. (B) 32mm with +4mm offset CoCr head ball with evidence of corrosion and metallic debris inside. (C) In vivo and (D) explanted Accolade I size 2.5 femoral stem with significant wear noted about the trunnion.

The patient was admitted and underwent revision left hip arthroplasty without complication. Intraoperative images from her revision surgery are shown in Figure 5. She was found to have extensive metallosis in the soft tissues surrounding the left hip along with advanced corrosion and loss of material at the femoral trunnion. Her femoral component was replaced with a long stem modular implant fitted with a 36mm ceramic head ball and her polyethylene
